## MARDEN VILLAGE DRAINS

25th February 2021

## MARDEN DRAINAGE CHECK

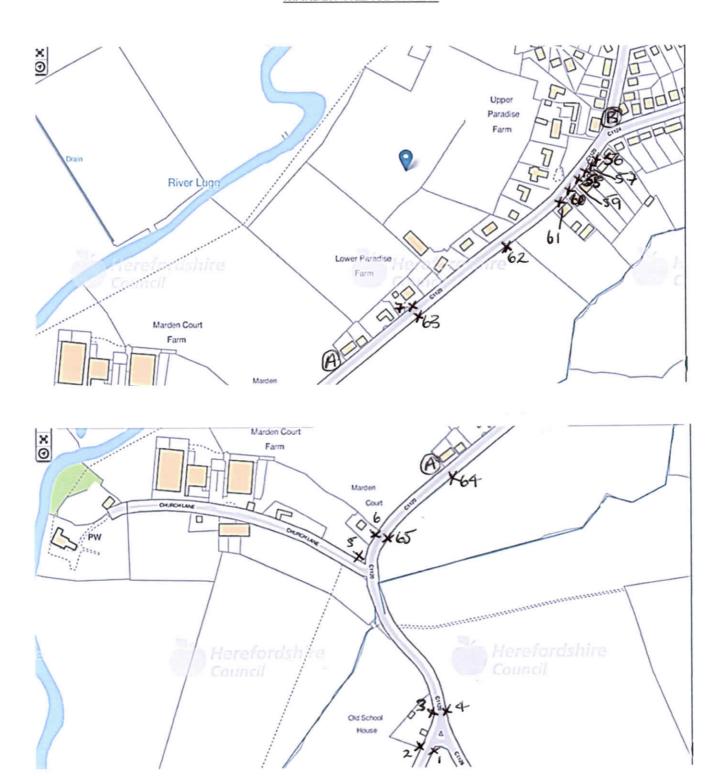
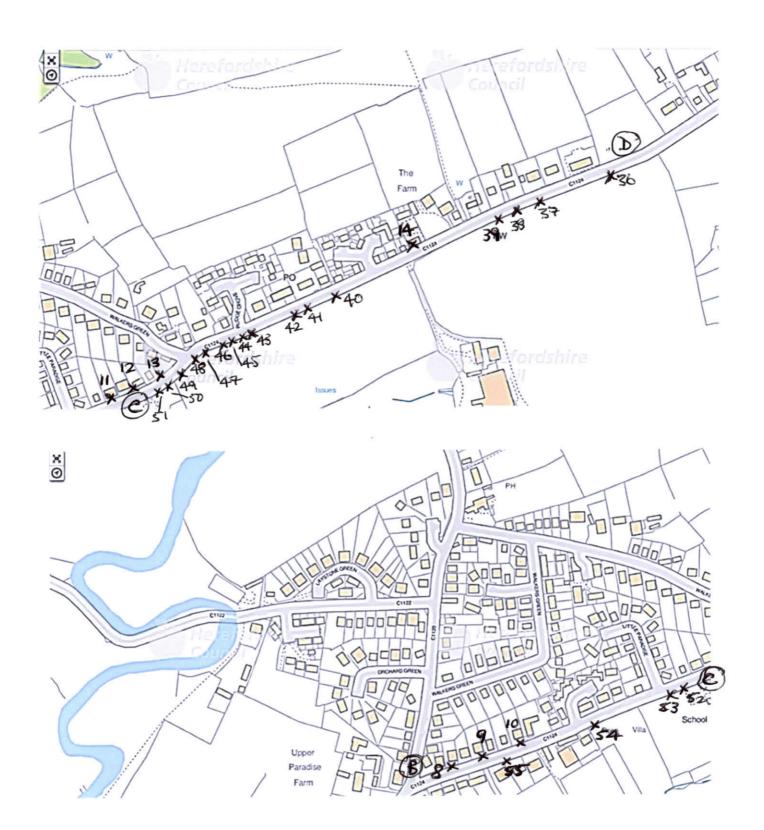
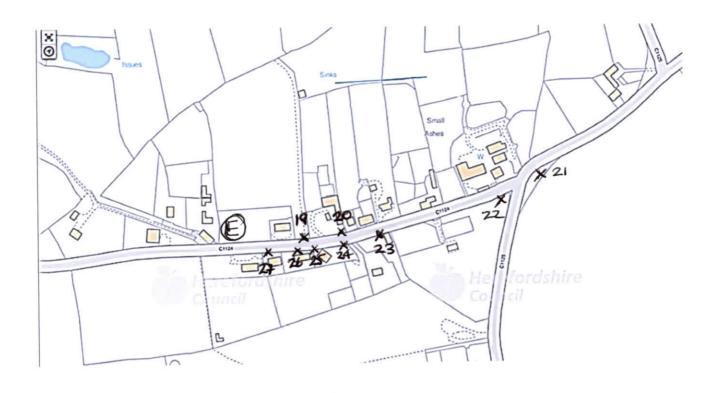
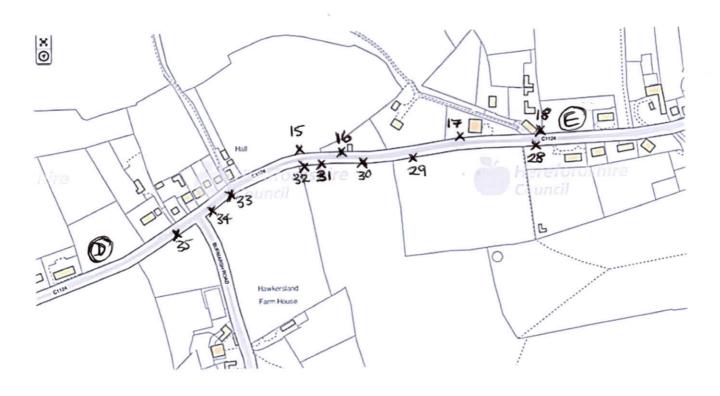
Number on map	Condition/action required
1-4 area	Chambers full, no improvement from jetting, needs gulley sucker and recycle vacuum
	Advise needs redesign of whole system on corner, major civils project, raise road level and put in proper land drainage
5	Ditch running but is not deep enough, washing debris into culvert pipe
12, 34, 35	There are problems in the main requiring a recycled vac unit to clear the mains.

Jetted, checked, draining well

6-11, 13-33, 36-65
